# The Mystery of the *St Michael*: Site Formation Processes and River Wrecks at Morpeth, New South Wales, Australia

## Abstract

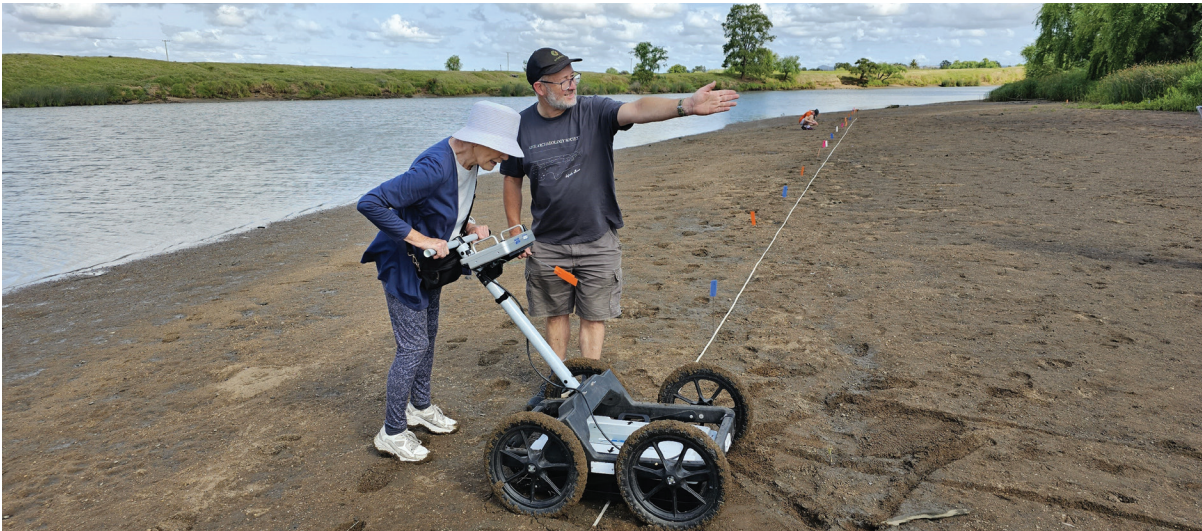
Figure 4. GPR survey of the sandbank opposite Morpeth at Taggarts Point showing Baseline 1 and pin flags that indicate the start of each survey lane. Image: Brad Duncan, 2023

Based on the possible relationship between the sandbar along Taggarts Point and the two wrecks, a ground penetrating radar (GPR) survey was undertaken on November 3, 2023, across accessible portions of the sandbar, coinciding with minimum low tide and extreme low water flow in the river. The visible ground surface of the exposed bar was sand and silt, standing only about 0.2 m above the water surface. The Mala Ground Explorer system fitted with a 250 MHz shielded antenna was able to achieve penetration depths of up to 8 m below ground despite the presence of brackish water (fig. 4). GPR velocity was set to 70 m/ns with a reading interval of 0.05 m.

It was possible to establish a southeast to northwest baseline parallel to the riverbank, with GPR transects running at 90 degrees (in a southwest to northeast orientation) toward the northern riverbank and spaced at 2 m intervals. Each transect was continued until reaching vegetation (reeds), fallen tree limbs, or the swampy back channel close to the high northern bank, a distance of

5–10 m. The beginnings and ends of large anomalies were plotted with steel pin flags. At the end of this survey, two longitudinal transects were taken through the middle of the group of anomalies in a southeast to northwest orientation (see fig. 5). A second baseline with similar 90-degree offsets was established to the southwest of Baseline 1, using the same methodology as outlined above, but no anomalies were encountered in this area.

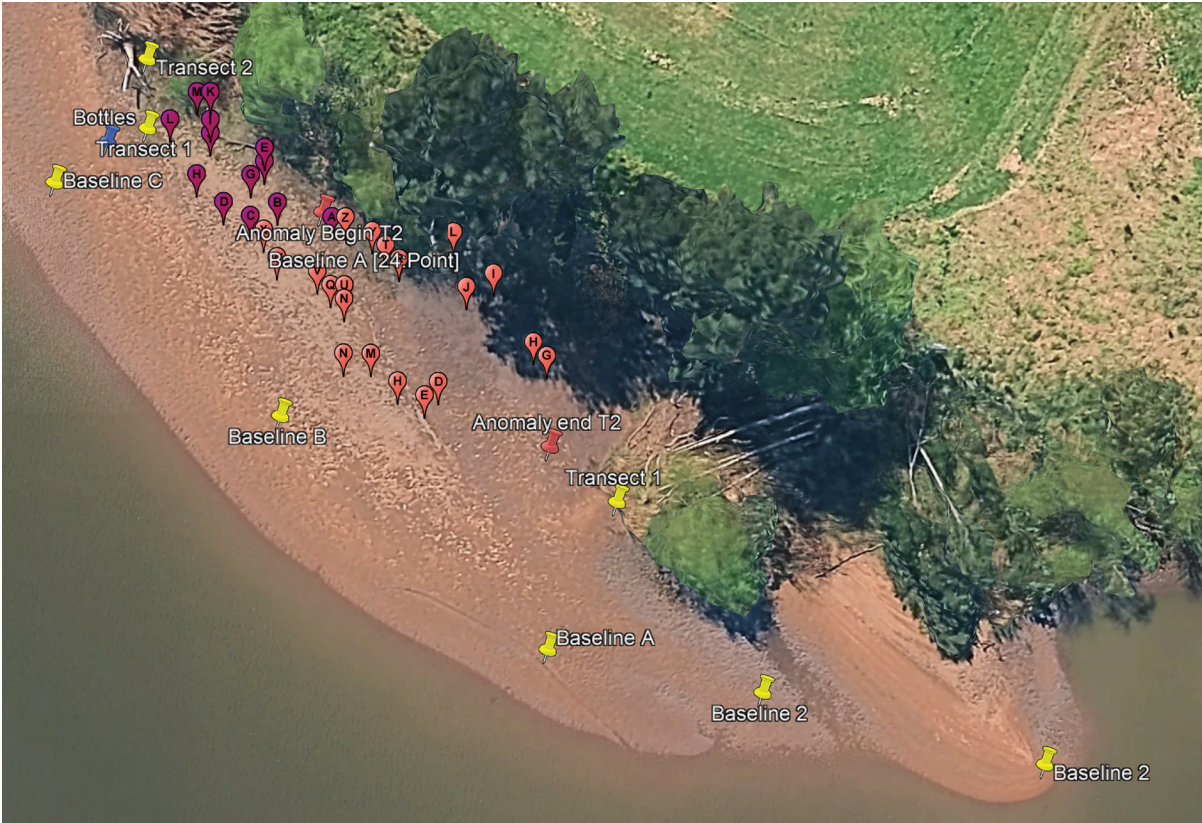
Figure 5. Locations of the extent of the anomaly, superimposed over Google Earth aerial imagery. Note yellow markers show the survey baseline extremities, with red and purple markers showing anomaly extents on each transect line. Image: Brad Duncan, 2023, after Google Earth map, December 2012

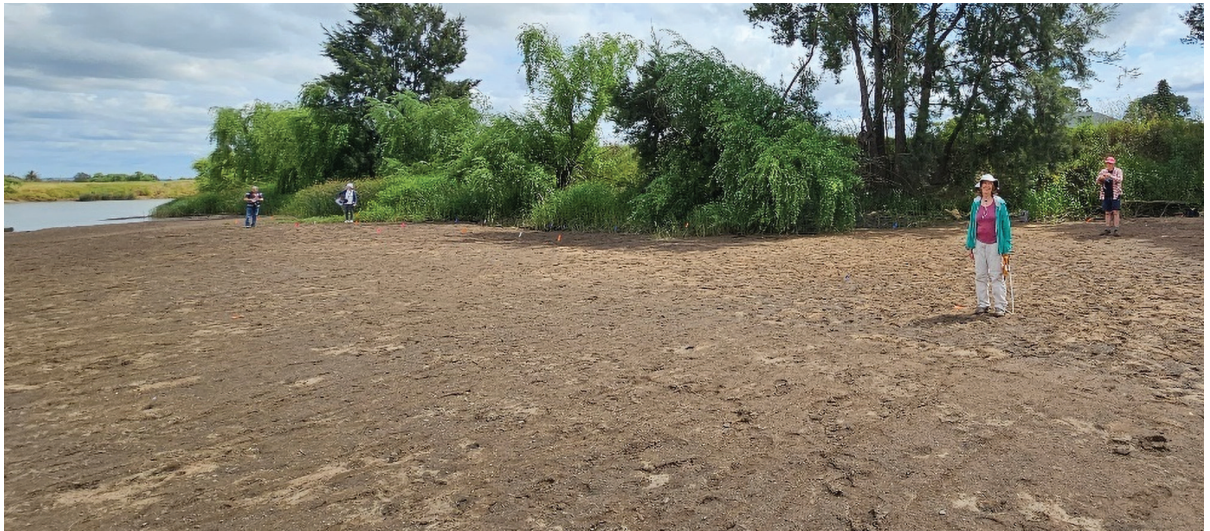
Figure 6. The location of the extent of the GPR anomalies between people standing at each end on the sandbank. Image: Brad Duncan, 2023
